U.S. Department of Transportation

2004

Natural Gas Delivery, Storage & LNG Pipeline Inspection Technologies Demonstration Report

Strategic Center for Natural Gas & Oil

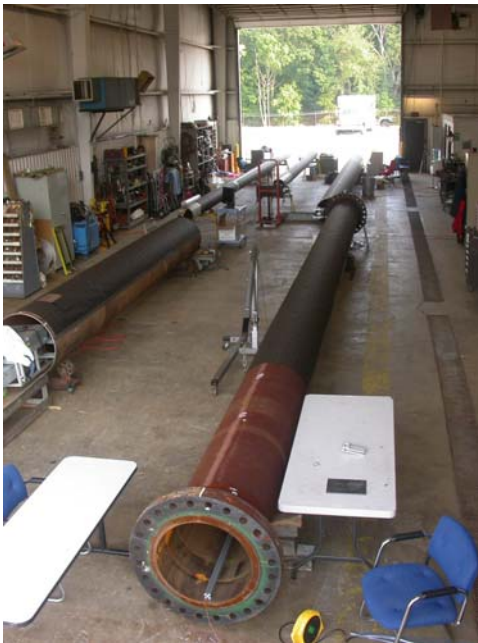
Figure 1 (left) north end of the high-bay area looking south. 30-inch SCC pipe and 24-inch mechanical damage pipe in foreground. Figure 2 (above) high-bay looking north. 12-inch corrosion and 24-inch mechanical damage pipe with gouges in foreground. Dent and gouge machine in far background outside the high-bay area.

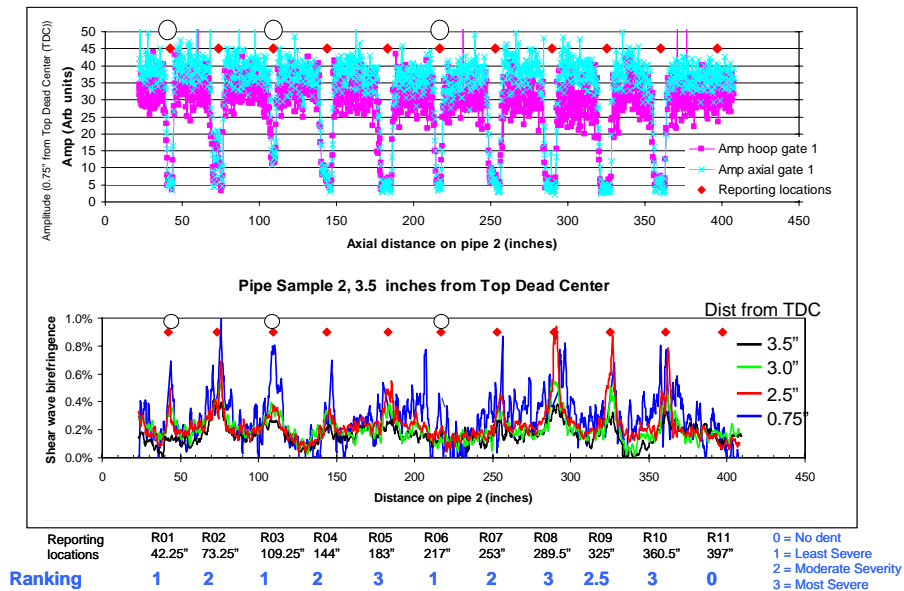
Figure 1. The amplitude of the ultrasonic signal as a function of axial distance on pipe 2 (top) and the shear wave birefringence as a function of axial distance on pipe 2. The red diamonds are the reporting locations.

The results from pipe 2 are especially encouraging. The pipes were scanned along the axis from the interior utilizing a non-contact Electromagnetic Acoustic Transducer (EMAT). The EMAT generated a wave which traveled through the thickness of the pipe every 0.2" along the axis. The figure below shown the amplitude of the ultrasonic wave as a function of position along the axis of pipe 2 that was 0.75" along the hoop direction from top dead center. The bottom figure shows an ultrasonic parameters called the shear wave birefringence, which is independent of the thickness of the pipe. This aspect is important since the action of deforming the pipe causes the pipe to become thinner and our goal is to determine the degree of residual stress and plastic strain due to the mechanical damage not just the thickness of the pipe. Our classification or ranking of the dent severity is in the bottom figure below. We correctly assessed the degree of deformation on 8 out of the 9 reporting locations. Our assessment for locations R04 and R05 we reversed and our assessment for R09 should have been 2 rather than 2.5. The reason for the deviation for R09 was due to the fact the damage from the indenter at locations R08 and R10 was severe and extended over a large region, causing additional damage near location R09.

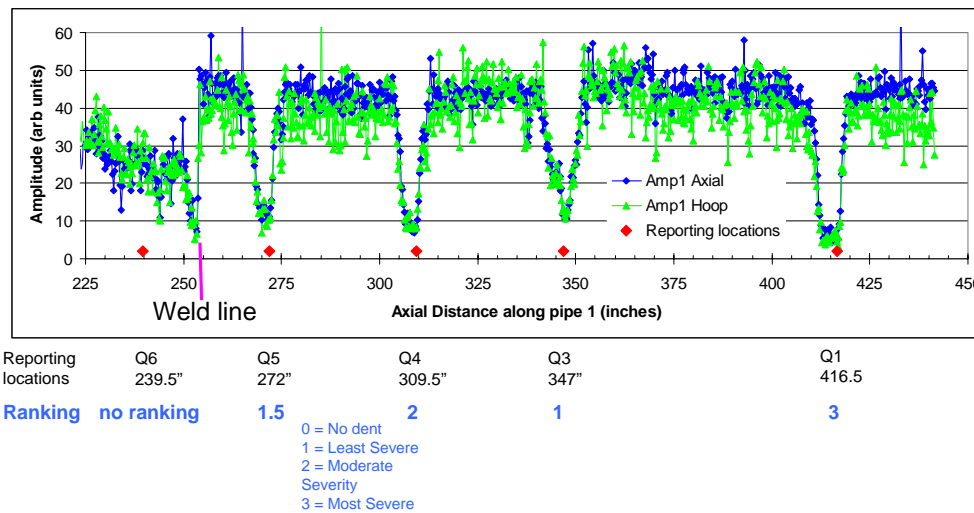
Figure 2. The amplitude of the ultrasonic signal as a function of axial distance on pipe 1. The red diamonds are the reporting locations.

Our assessment of pipe 1 was complicated due to the complex processing history of the pipe. After denting Pipe 1, it was ruptured during a pressure test, releasing some of the residual stress in the region of the calibration defects. In addition, the pipe was cut and a portion was rotated to align defects, then welded back together. The result was a set of calibration defects that existed in a section that was different than the reporting locations. Even with these complications our assessment was reasonably accurate, with our ranking for Q4 and Q5 correlating nicely with the degree of damage. Figure 2 shows the amplitude of the ultrasonic signal along the axis of pipe 2 for two different polarization of the shear wave. The location of the dents is clearly visible as is the difference in the material properties as the EMAT moved across the weld line of the pipes at ~250 inches.

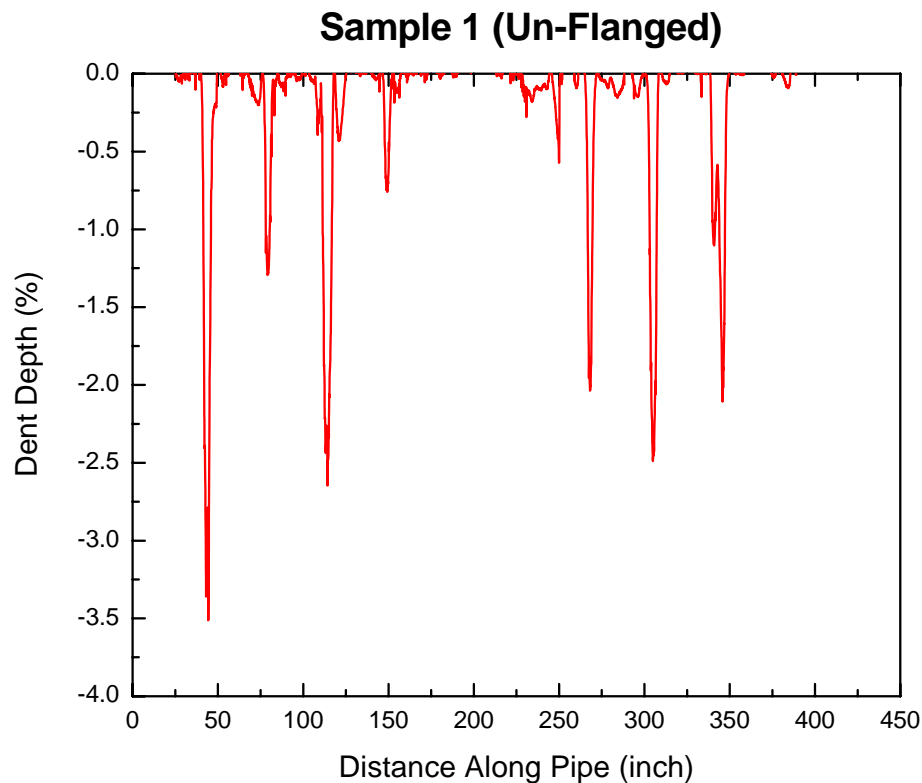
The raw data above indicates that the measured dent depth for Sample 1 never exceeded 3.5% consistent with the benchmark information. The figure below shows the raw data from Sample 2.

As regards to reporting erroneously higher dent depth, we found our mistake to be wrong calibration. In fact, all results got multiplied by a factor of 1.6. The raw data obtained from the tests on the two pipes are included below and these are closer to the benchmark values as it should have been.

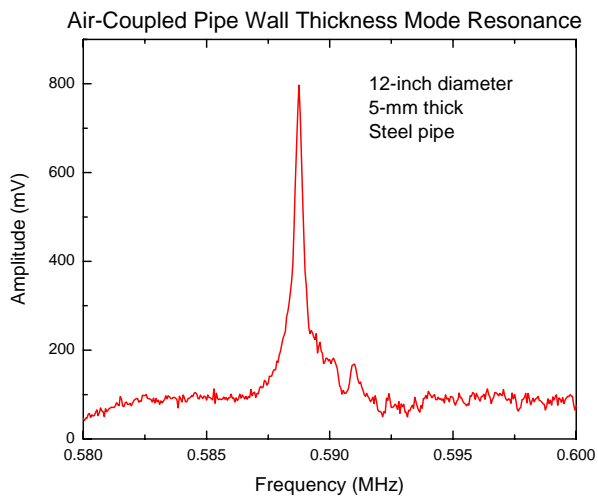
For completeness, since several observers at the test facility had expressed an interest in our ultrasonic wall thickness measurement, an example data from laboratory test on a steel pipe at **ambient** pressure and from a stand-off distance of 2-cm (air coupled) is shown below. The resonance frequency is a direct measure of wall thickness.
